# RADFORD UNIVERSITY

## BMP INSPECTION REPORT

Project Number: 2429.3

Date: August 30, 2024

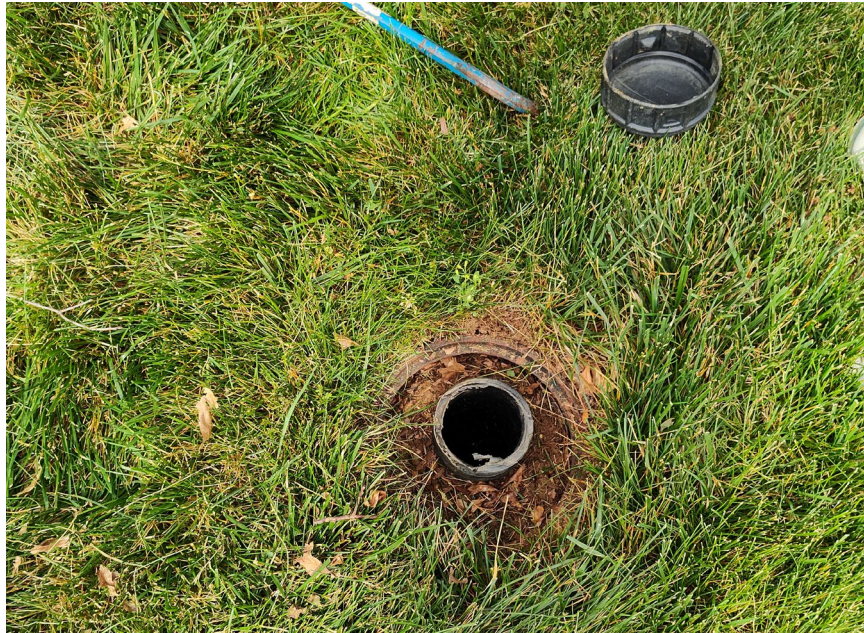
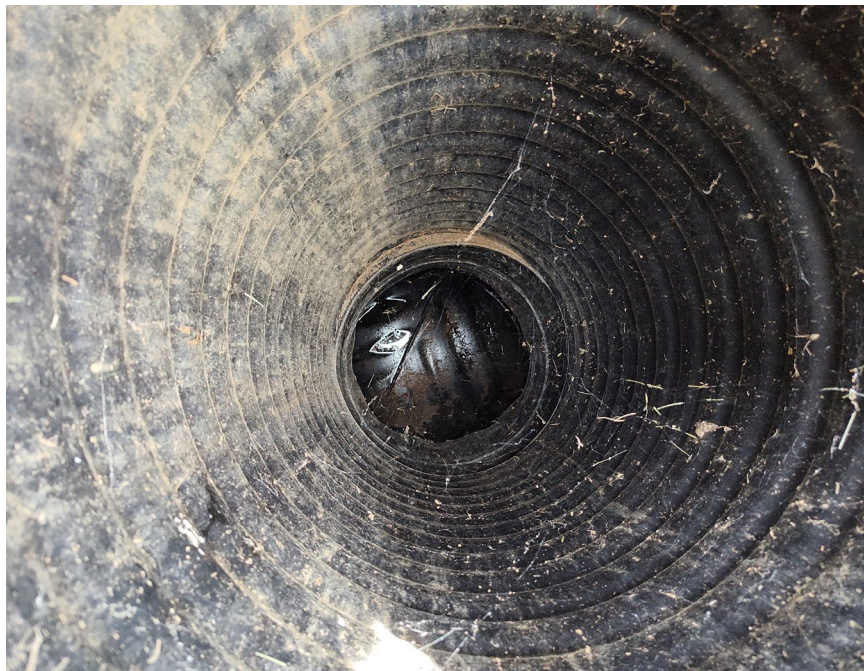
### RU-BMP-IF-1 – UNDERGROUND STORAGE

- Manhole access and observation ports checked. Small bits of sediment in sections. Sediment has not reached the 5% range. Recommend cleaning once the 5% level has been reached.

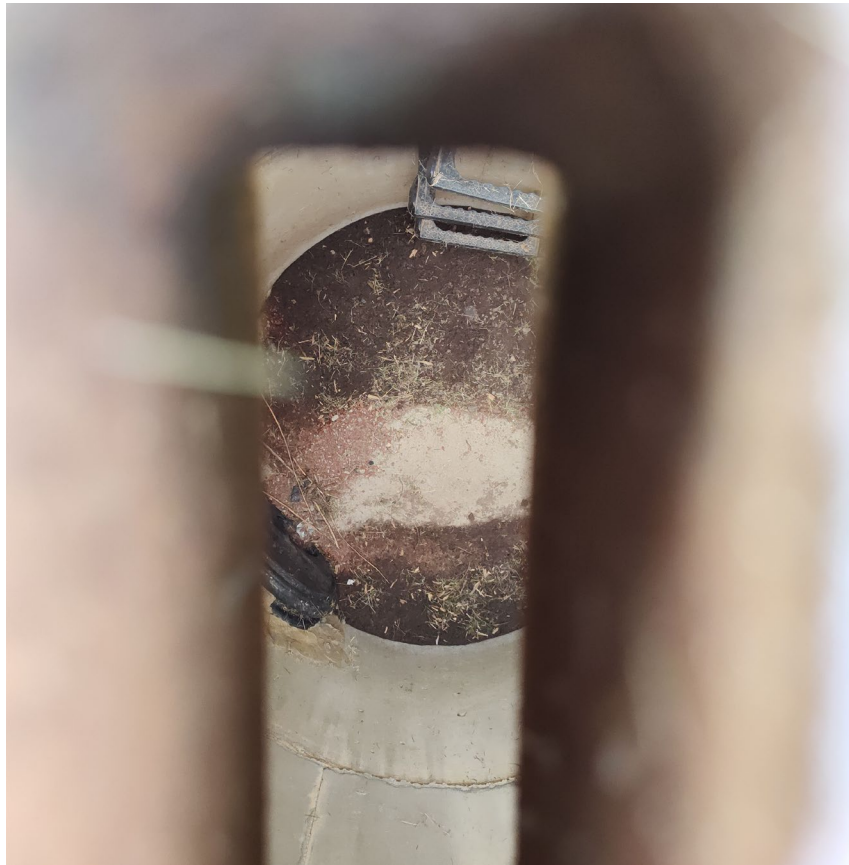
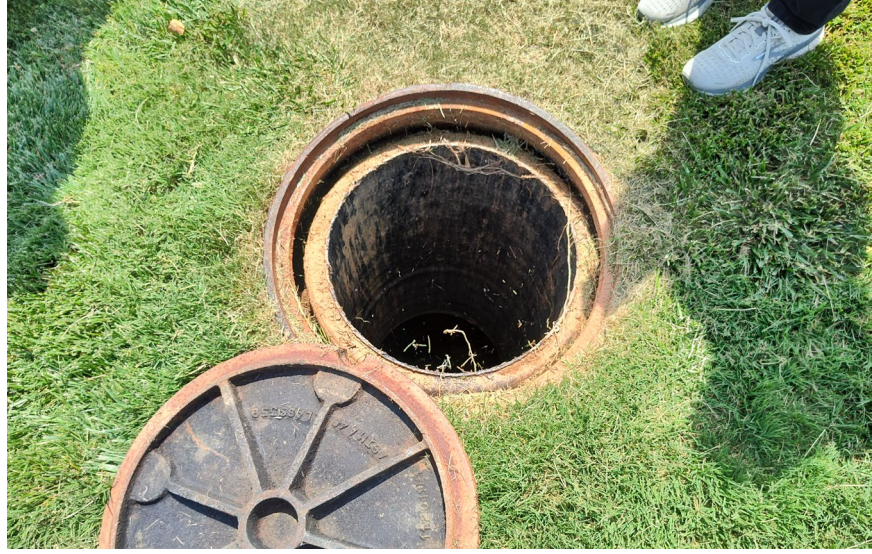
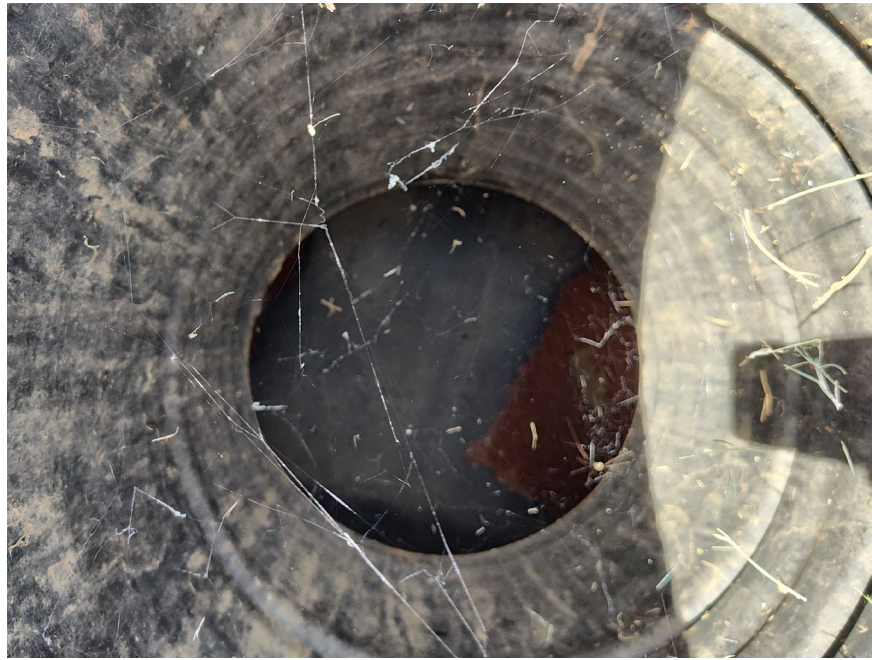
## RU-BMP-HF-1 – UNDERGROUND STORAGE

- Sediment in various sections of pipe and riser. Sediment had previously reached close to the 5% range due to pine needles and riprap from the upper drainage area of the softball field. Much of the sediment, pine needles and riprap were removed. To address this issue, RU removed the pine trees from the softball field. From initial observations, there are some small pieces of riprap in the pipe sections, but the majority of the sediment and needles are gone. Monitoring of the system is recommended at this point to ensure that additional sediment does not increase the total percent. Recommend increase in maintenance schedule.

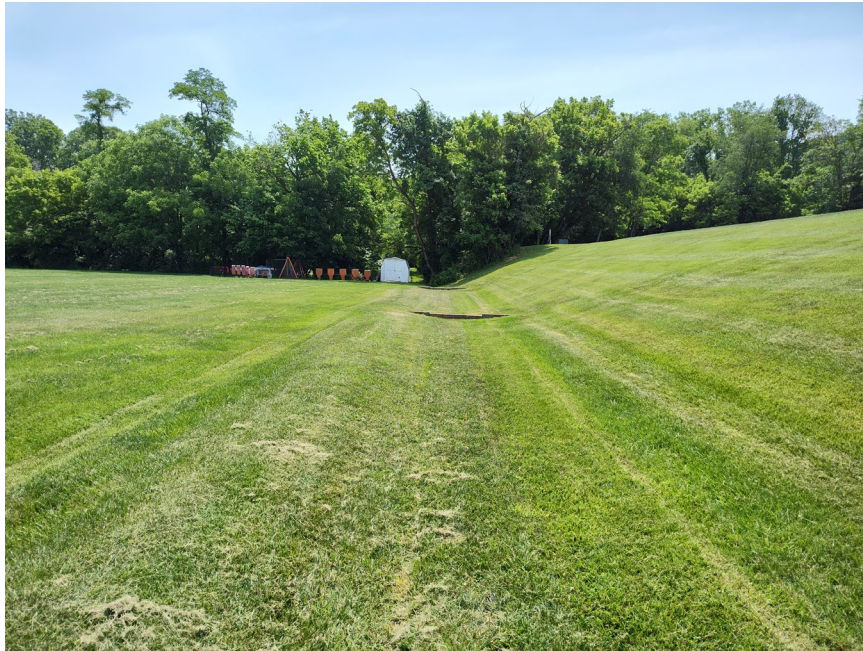
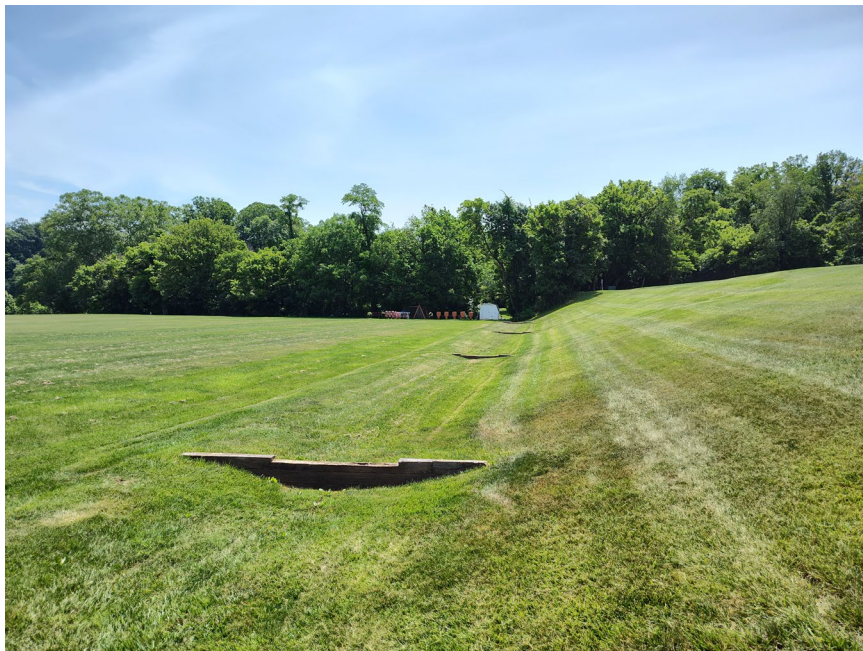
## RU-BMP-HF-1 – GRASSED SWALE

- RU staff to continue to keep heavy mowing equipment off swale area to avoid bio media compaction. Site stable and well maintained. Check observation ports to make sure equipment is not damaging caps.

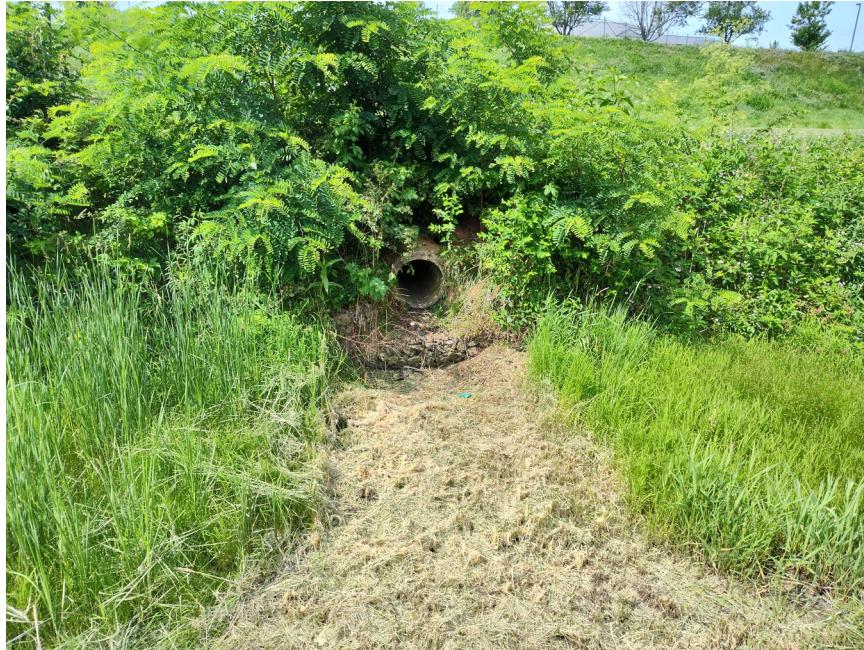
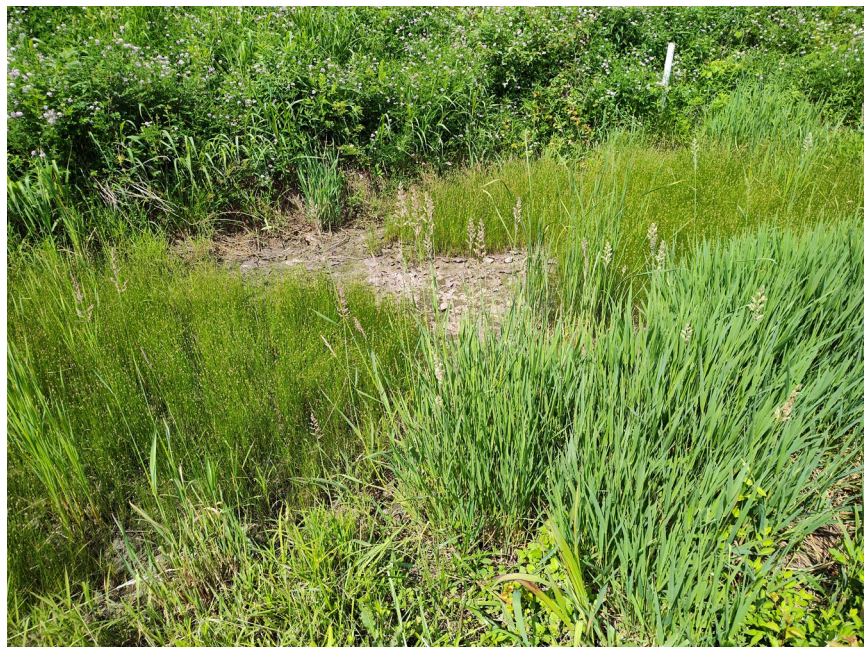
## RU-BMP-WT-1 – CONSTRUCTED WETLANDS

- Overall site has some vegetation; therefore, regular maintenance and mowing is required to maintain the slopes and allow better inspection of the entire BMP. Some sediment buildup in the forebay. RU staff to monitor if sediment removal is required.

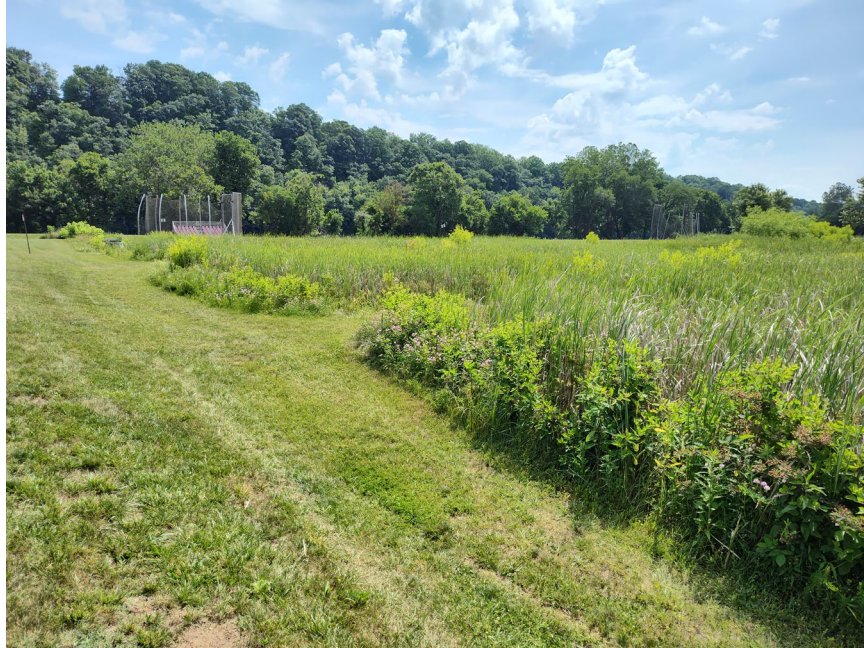
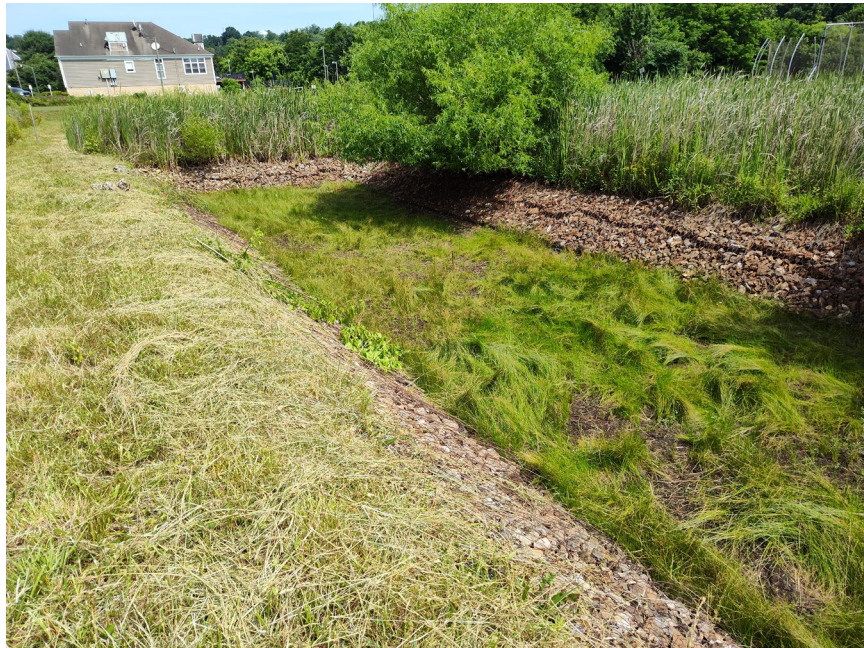
- Excess vegetation was removed to allow access to all of the BMP. Based upon the 2016 & 2018 report, invasive species were identified in the wetland cells. The original plan has a schedule for the high and low mashes. Currently there are cattails and phragmites within the wetland area. Control of those invasive species should be implemented and monitored if they reach 15% of the wetland cell. RU staff should continue to monitor the extent of the invasive species.

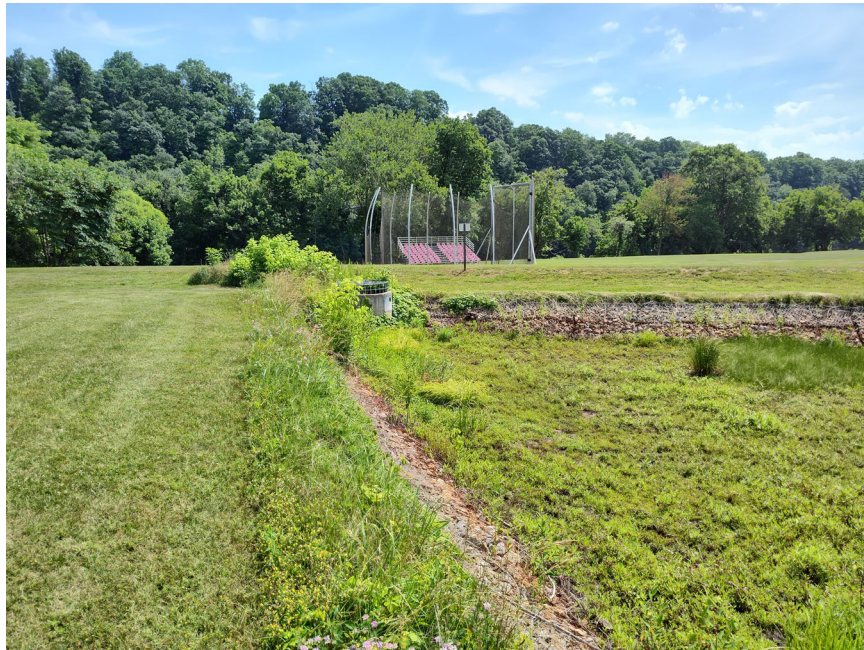
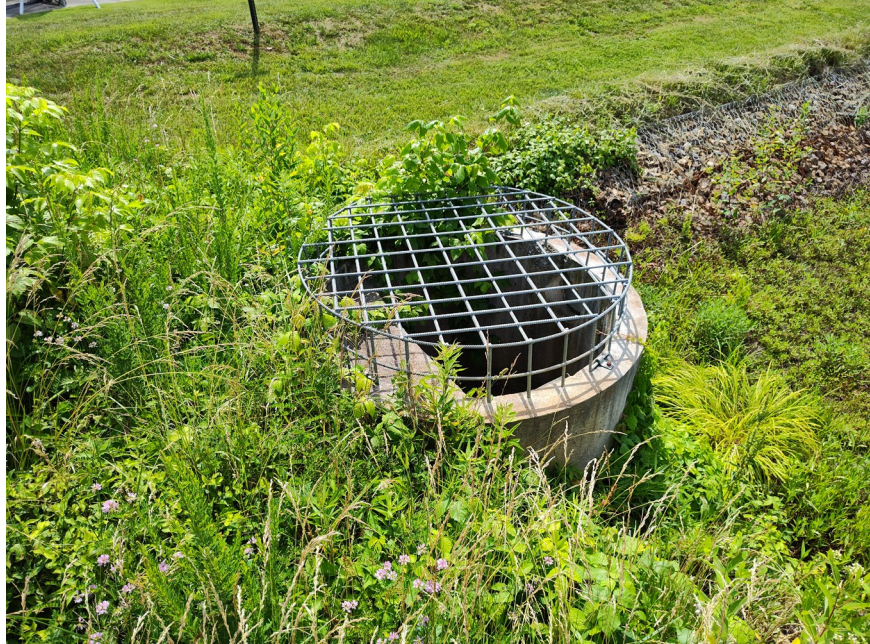
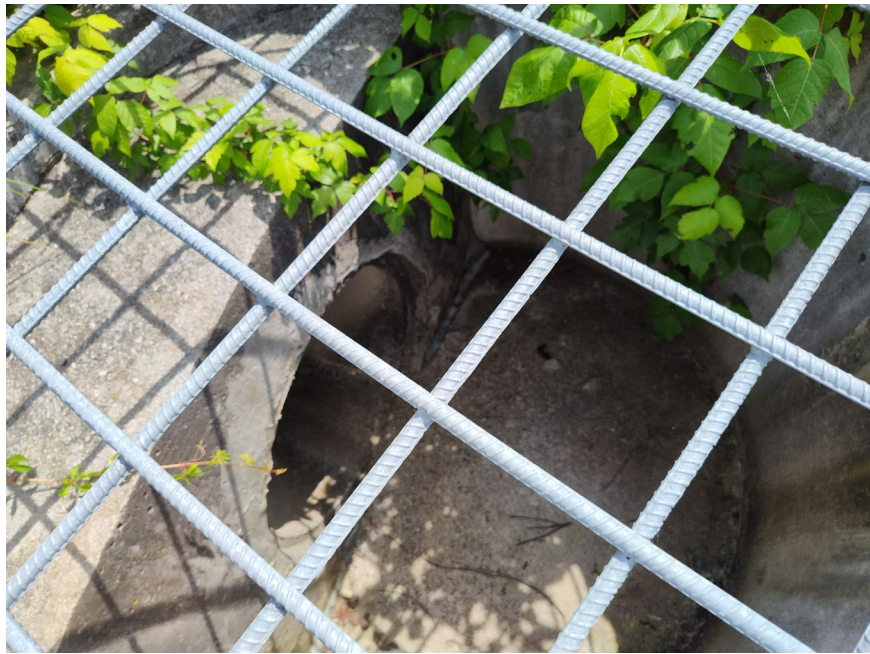
- The last report determined that there was a leak in the riser structure and RU staff had implemented some temporary measures to plug the leaks. Unfortunately, those measures did not keep the leak from draining the majority of the deep pools and shallow areas of the wetlands. It was observed that the permanent pool areas have been drained and the wetland plants are in danger of dying out from dry conditions. Repairs need to be implemented to the riser immediately.

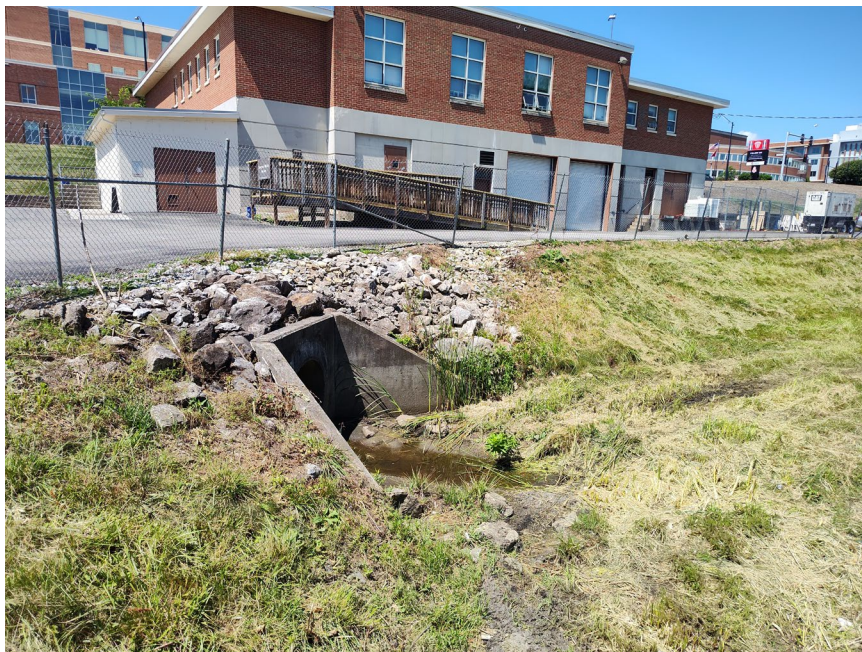
## RU-BMP-AL-1 – DETENTION POND

- The University had previously seeded the pond to stabilize the facility and it was recommended to increase the normal maintenance cycle due to sediment in the bottom of the facility.

From the previous report, there does not seem to be any additional sediment deposited since the last scheduled removal of debris. Even though there is no additional sediment deposited, it is recommended to camera the pipe starting at the outfall into the basin if more sediment is introduced onto the pond. With the sediment removal previously done, riprap should be added back to missing sections at the outfall. RU staff to continue to monitor any sediment into the pond.

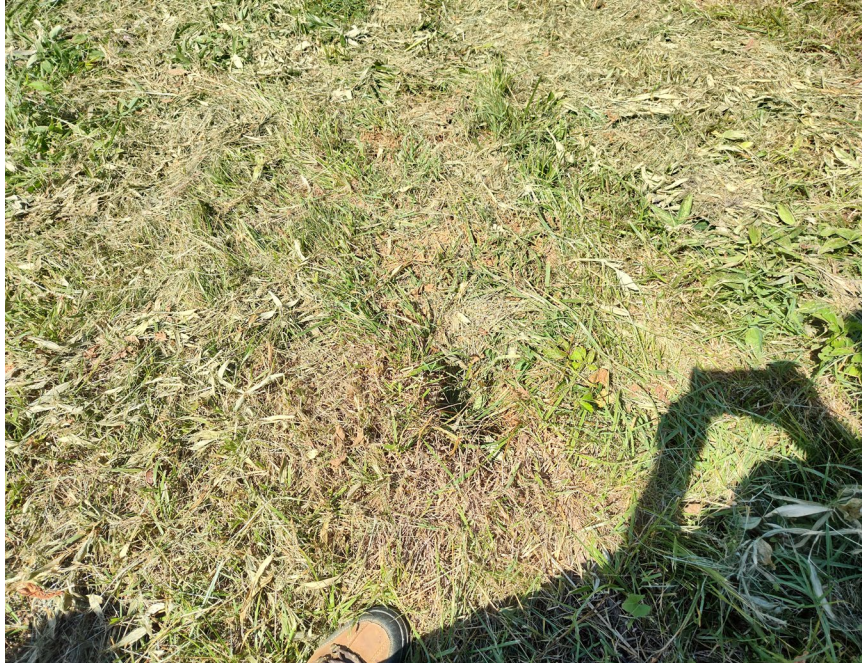
- A vermin hole was located along the berm near the gas line area. Traps should be set to capture the vermin and remove it from the basin area. This one is noted near the area of the gas line and is of concern since this is the weak point on the berm structure.

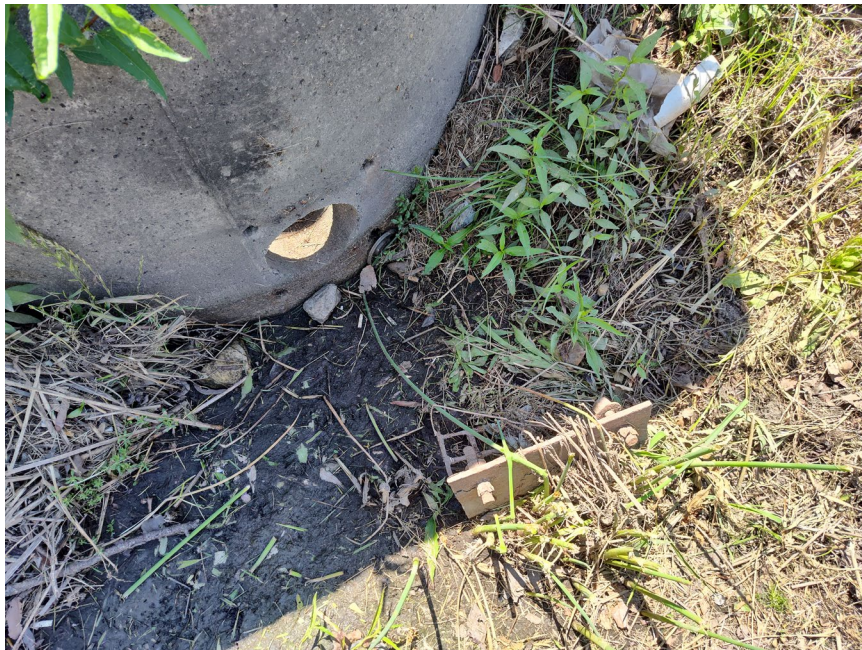
- It was also noted that the trash rack needs to be reinstalled on the riser structure or replaced.

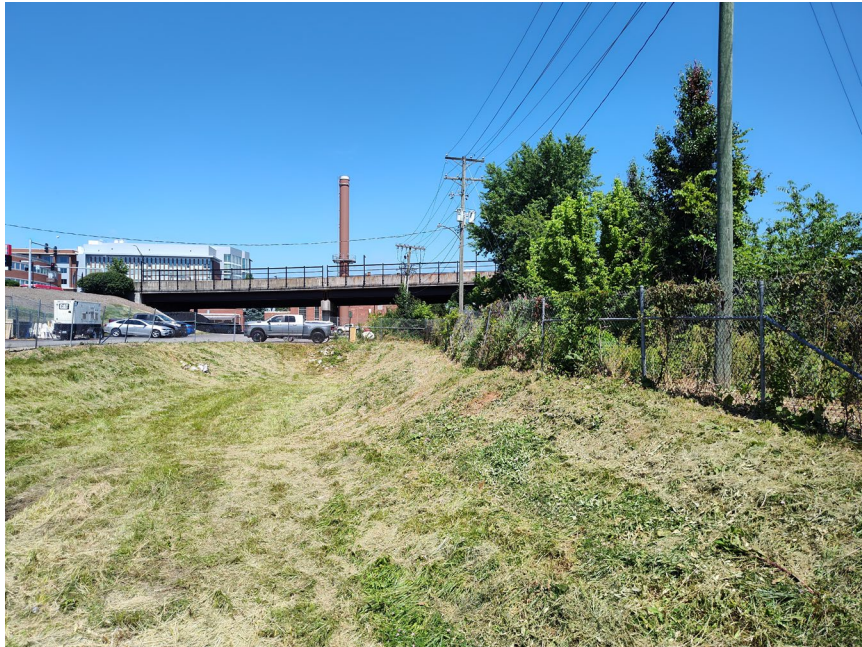
- As reported in the last inspection, the berm area near the gas line installation shall continue to be monitored for seepage or compromise. No signs of erosion or seepage during this inspection. It is recommended to address the berm section by adding fill to the area. Slopes may be adjusted internally to keep the same volume for the pond to ensure that storage remains adequate. Over time this has the potential to fail for a higher storm event.

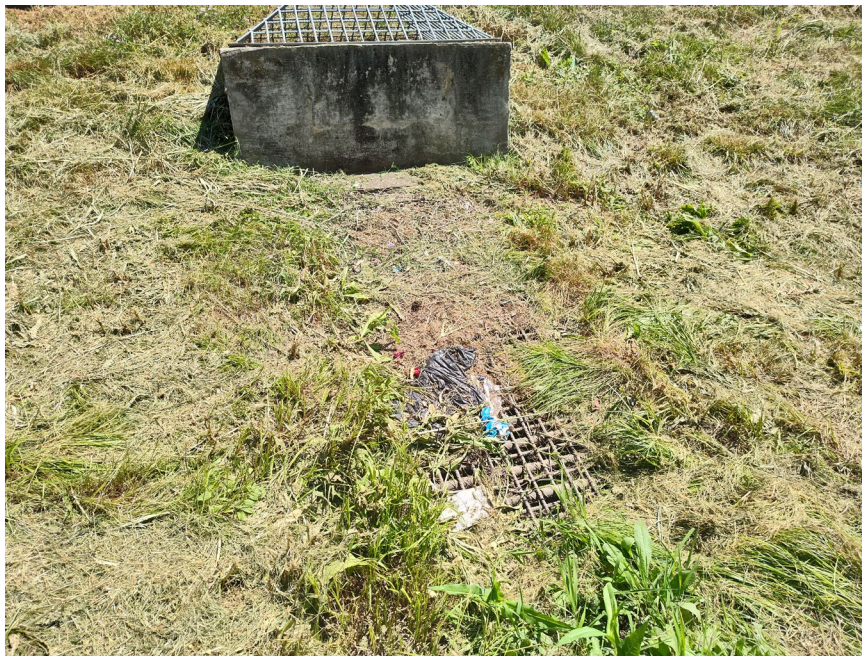
#### **RU-BMP-AR-1 – DETENTION POND**

- The University had seeded the pond area for stabilization of the BMP and increased the frequency of the maintenance schedule. It was noted fresh grass clipping should be removed from the trash rack.

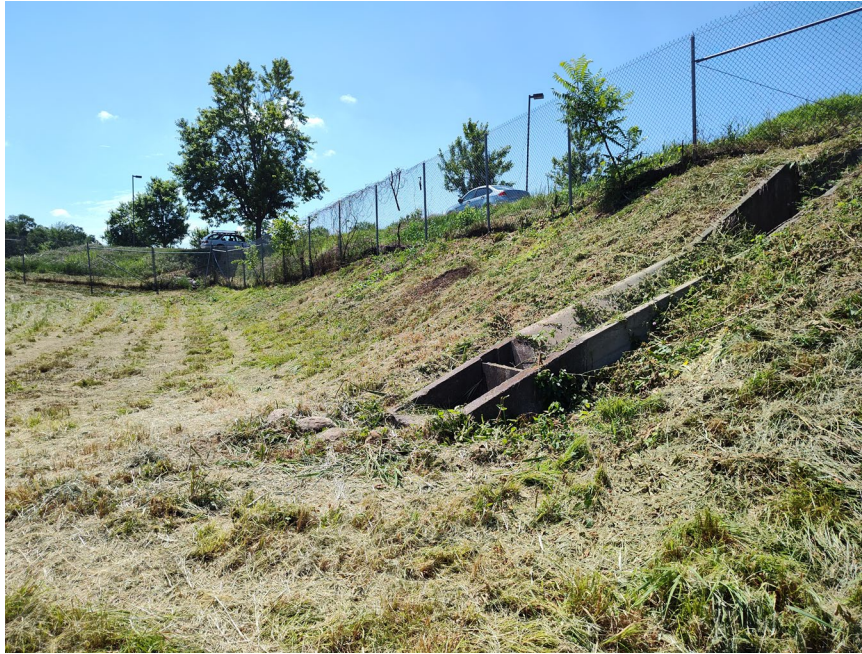
- Inlet pipe with outfall concrete channel showed signs of separation which resulted in erosion around structure in 2018. University staff replaced the structure to prevent further erosion on outfall channel. New structure remains in good shape and no signs of erosion.

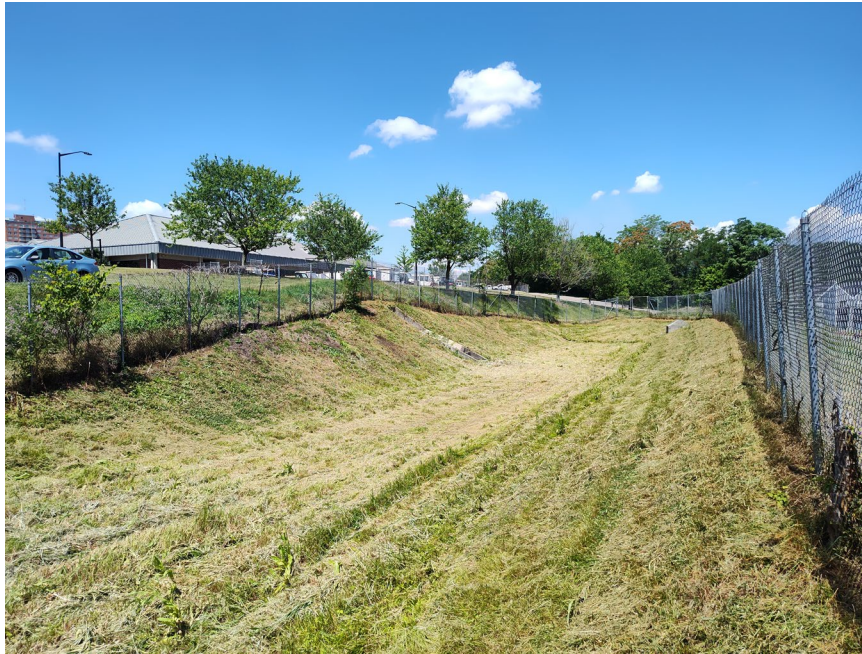
- Nuisance animals had been noted to be in the area of the BMP and have been caught in recent years. RU staff to keep traps out and fill holes immediately. Recent inspection discovered additional signs of holes along the downstream portion of the basin. Set traps to capture vermin and remove from the area. Recommend increasing the schedule for mowing to allow for better inspection of the berm structure.

Sediment from the parking lot and road area above consists of small gravel deposits. Those deposits have collected in the center of the pond bottom. This has caused the upper section of the pond to not fully drain to the riser section. It is recommended to remove the sediment/gravel deposit from the center of the pond and reseed. This will help drain the pond faster after a rain event.

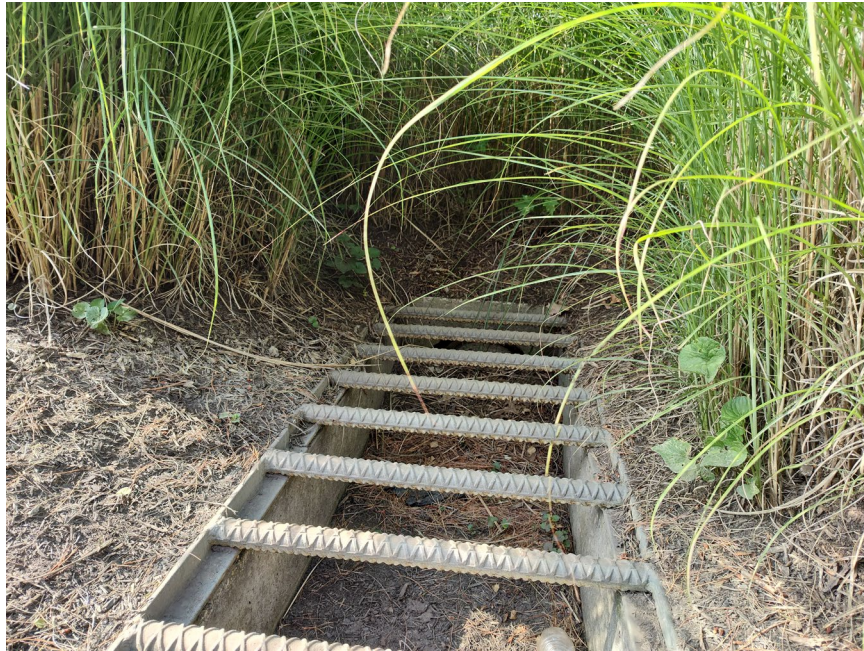
## RU-BMP-CH-1 – DETENTION POND

- Overall, the facility has been kept in good condition. RU staff will continue to pick up trash and debris. No debris near the riser section.

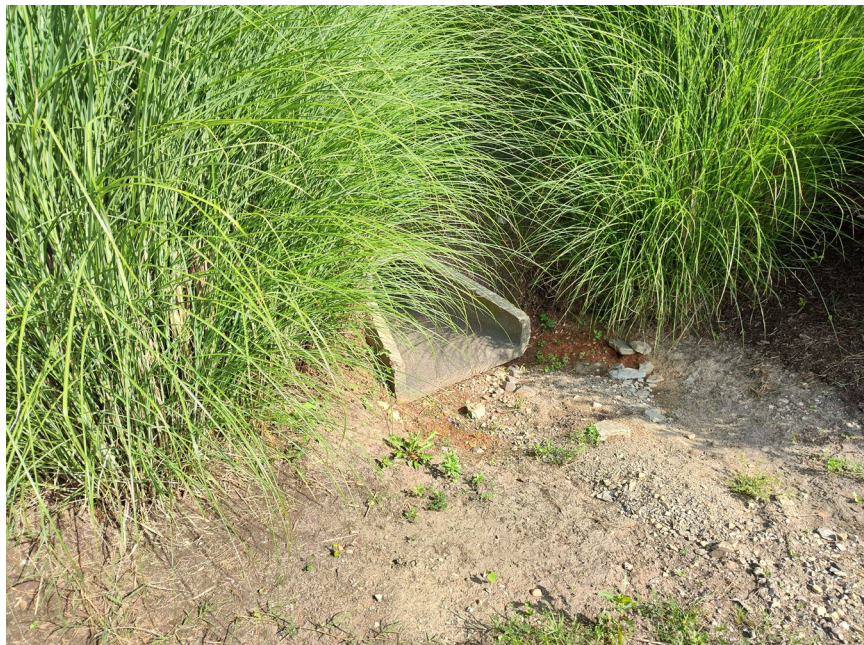
- Add riprap to the outfall section. Noted sediment of gravel mixture buildup at outfall. Source was traced to parking lot. Monitor and remove sediment and debris as needed.

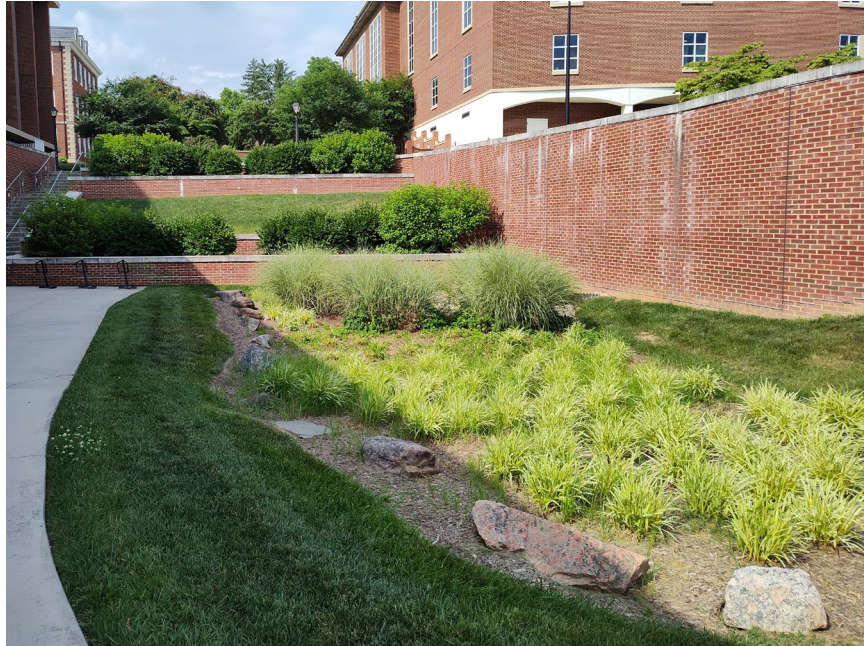
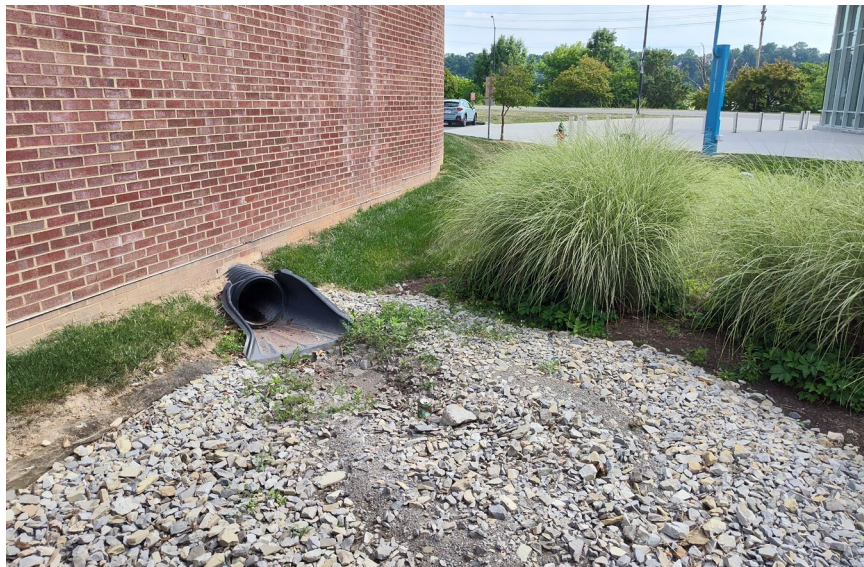
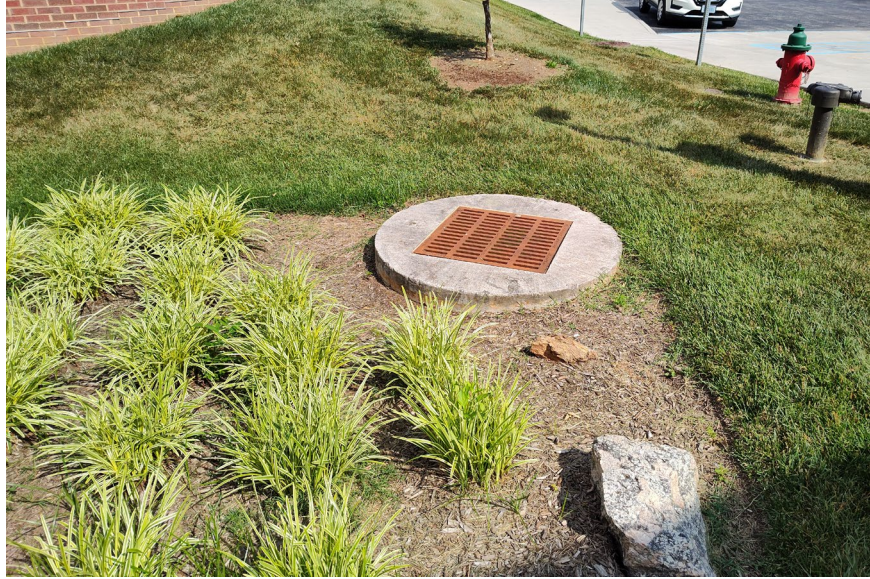
## RU-BMP-SC-1 – BIORETENTION

- The BMP is in good condition with some apparent trash from drainage area. Plants and mulch have been maintained. No issues with the underdrain or media. Cleaned up and removed some debris noted in the forebay area.

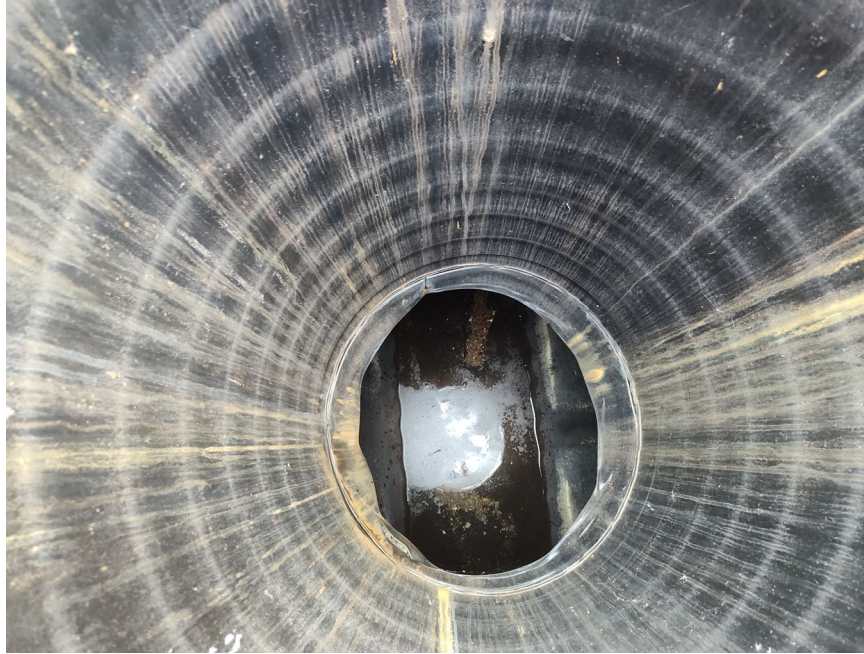
## RU-BMP-HU-1 – UNDERGROUND DETENTION

- Sediment in structure is less than 5%. Removal of sediment is required once 5% has been reached to ensure proper function of detention system. It is noted that the Humanities Building HVAC units send condensation water to the facility at various times. Outfall was checked to ensure no blockage was impeding flow.

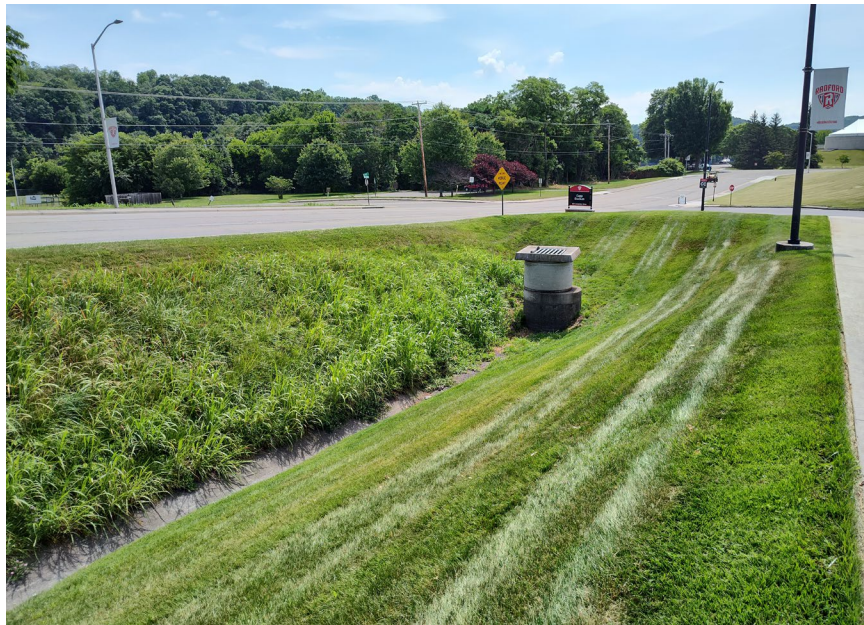
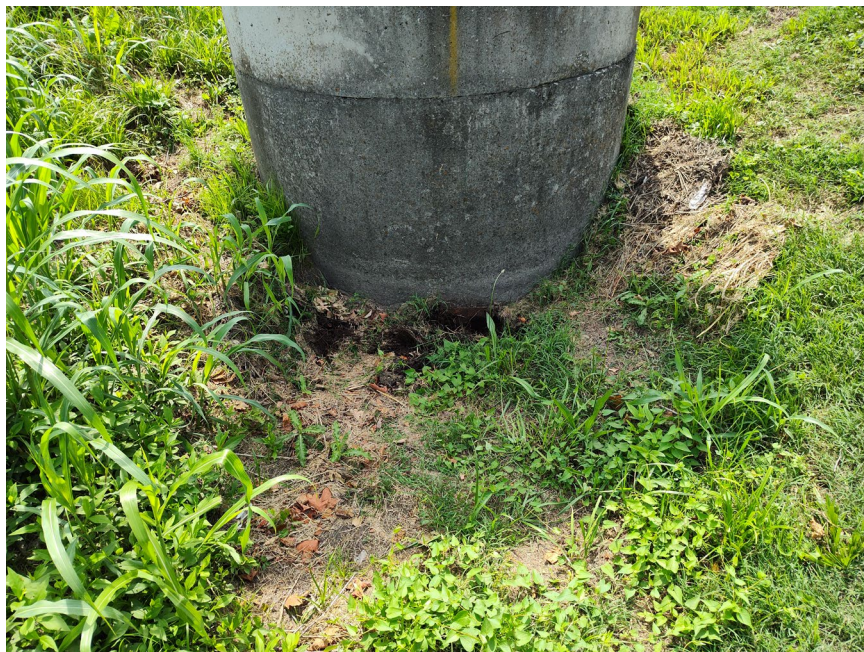
### RU-BMP-CU-1 –DETENTION POND

- Overall facility is in good condition with no signs of erosion near the roadway.
- Recommend increasing the schedule for vegetation removal along the slopes. Excess vegetation in a few areas.
- Debris and sediment found near the riser orifice. Sediment blocks lower orifice from functioning. Remove immediately. Recommend a new trash rack be installed to help with sediment build up conditions.

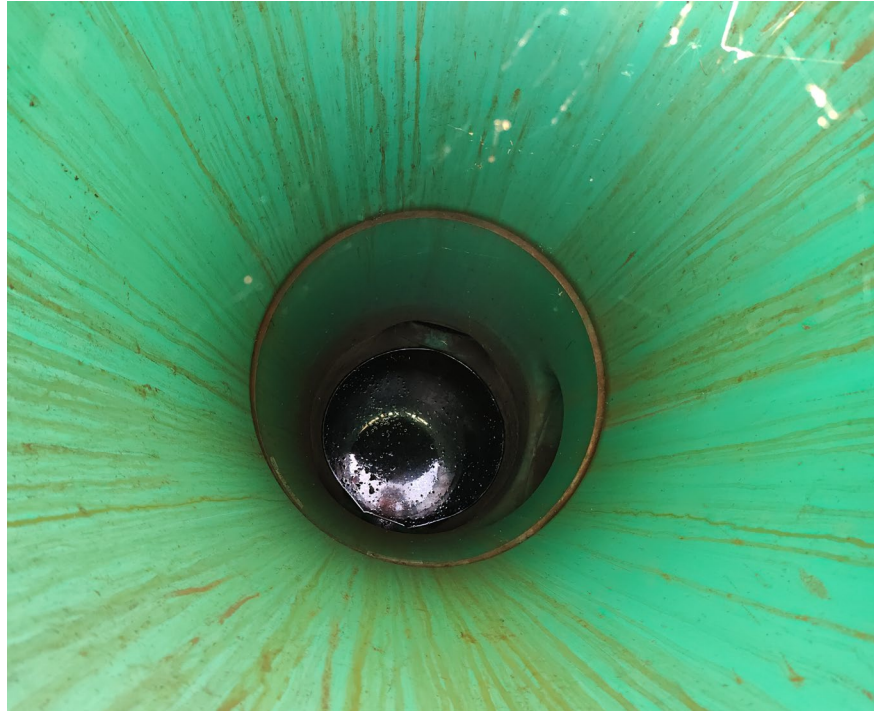
## RU-BMP-FF-1 –UNDERGROUND DETENTION POND

- Overall facility is in good condition since it is relatively new. There has been no sediment accumulation occurring due to its recent construction. System should continue to be monitored.
